FACILITIES EVALUATION - 1105 MASSACHUSETTS AVENUE

April 25, 2011

Facilities Evaluation -- 1105 Massachusetts Avenue, Cambridge

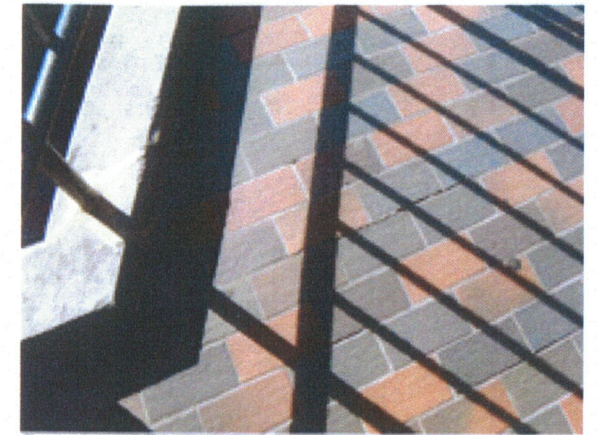
Entry Level Terrace Detail

| 1.00 | SITWORK | | | | | |
|---|---|---|---|---|--|---|
| 1A.02 | Terra Cotta Pavers | X | | 20 Years | 750 SF @ \$30/SF = \$22,500 x 1.2 = \$27,000 | German tiles are at the end of their useful life and no longer available. Extensive patching is evident, and tiles are missing in several places. Replace entire finish near-term. |

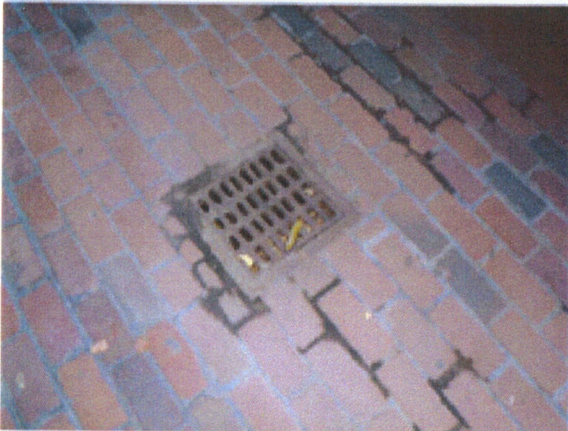
Lower Level Terrace Detail at Drain

| 1.00 | SITWORK | | | | | |
|---|---|---|---|---|--|---|
| 1C.03 | Terrace Storm Drains | X | | 30 Years. | Approximately 6 | Coordinate replacement with terrace replacement Item 1A.03. |

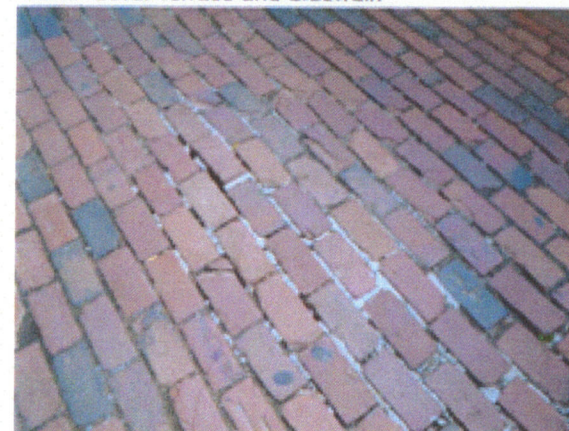
Lower Level Terrace Detail

| 1.00 | SITWORK | | | | | |
|---|---|---|---|---|--|---|
| 1A.03 | Brick Pavers | X | | 20 Years | 2,500 SF @ \$35/SF = \$87,500 x 1.2 = \$105,000 | The surface is badly deteriorated, extensively patched and repaired over the years, and will require complete replacement near-term. |

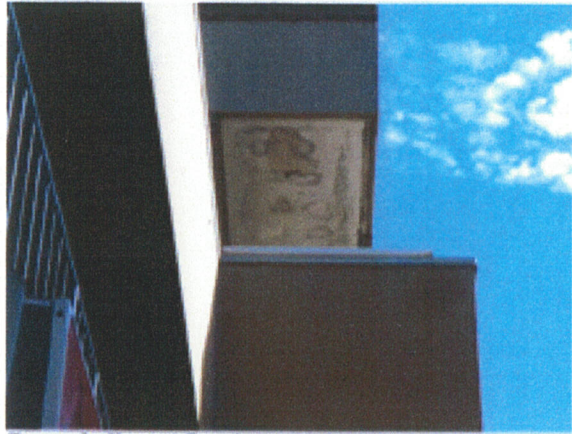
Tower Soffit and Fascias

| 2B.04 | Stucco Fascias and Soffits | X | | 45 Years | Fascias: 1,850 SF (Approximately) Soffits: 2,250 SF (Approximately) Total Stucco: 4,100 SF Patching and Staining @ \$5.00/SF = \$20,500 Replacement Budget: \$150,000 | While there is evidence of some patching, stucco integrity generally does not appear to have been compromised, despite its age. From this perspective, wholesale replacement is therefore likely not required in the near term. However, there is considerable evidence of chronic water infiltration and consequent staining, particularly at the building west end. Observation during a recent rain event revealed dampness at the base of the upper fascias and into the soffits, suggesting a possible discontinuity in the west end roofing system. Since by contrast, dampness was not visible at the east end, testing of the west end roofing system to detect the origin of infiltration seems indicated. To address the unsightliness of the stained and patched areas, application of a semi-transparent stain might be considered as a less-costly alternative to wholesale replacement. Prior to wholesale staining, an area should be tested to verify compatibility with the fascia material. The material appears to be an epoxy-based, stucco-like system on fiberglass mesh, such as "Drivit". |

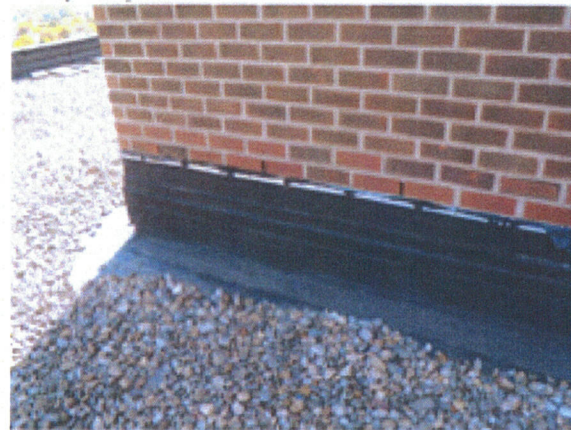
Counterflashing at Masonry and Roof

| 2A.08 | Deteriorated Flashing | X | | 40 Years | Assume 50 LF @ \$300/LF = \$1,500 | Through-wall counter flashing and head flashing at wall openings is original and thus over 35 years old. This material may begin to fail and allow water infiltration during the term. If necessary, replacement will require costly dismantling of the veneer brick.. Budget for some replacement late in the term. Combine with veneer masonry repair 2B.01. |

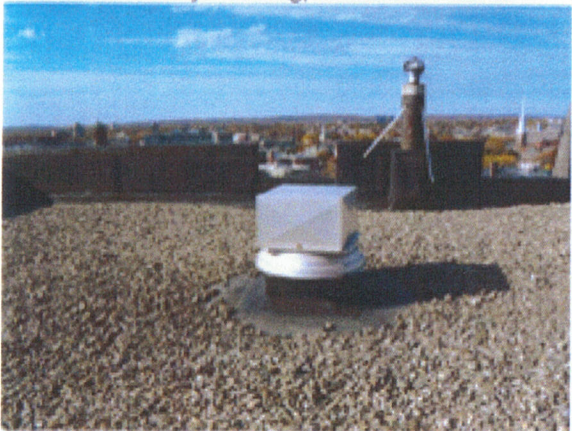
Rooftop Equipment, Ballast, & Parapet Flashing

| 2A.02 | Main Tower Roof | X | | 25 Years. | \$100,000 - \$125,000 Roof and Disposal \$12,000 Materials Hoist Erection \$4,000/Month Hoist Rental | Ballasted roof installed in 1982 and at the end of its useful life. When penthouse roof was replaced, the surplus ballast from that operation was thrown onto this roof. Roof replacement cost must take disposition of the ballast into account. Suggest considering installation of a materials hoist secured to the north building wall, with ground transport of ballast via barrows to sidewalk dumpster. Assume new roof will be adhered membrane over insulation. |

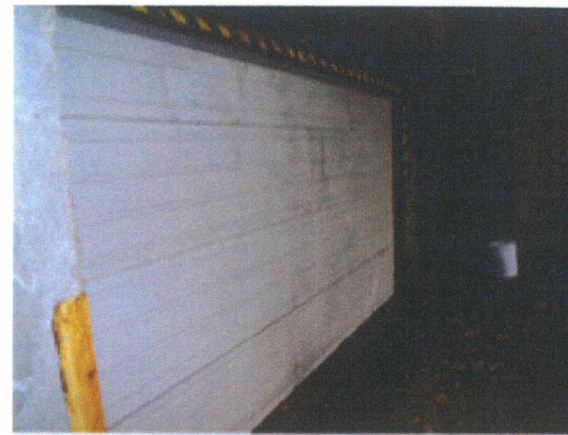
| 2B.11 | Garage Overhead Door | X | | 3 Years | Allow \$2,500 | This door receives hard use and must be routinely replaced. |

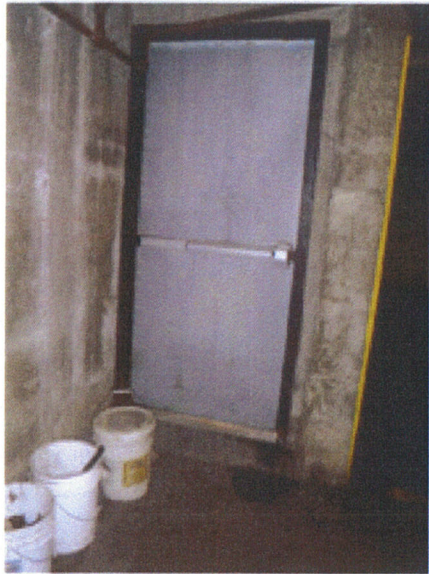
Garage Exit Door to Street

| 1D.03 | Garage Egress Stair | X | | 35 Years. | \$20,000 Allowance | Open stairwell is a health and safety hazard and is subject to vandalism, excessive weathering, and other damage. It is an attractive nuisance. Suggest that the stairwell be enclosed near term with a headhouse constructed of secure, vandal-resistant materials. |

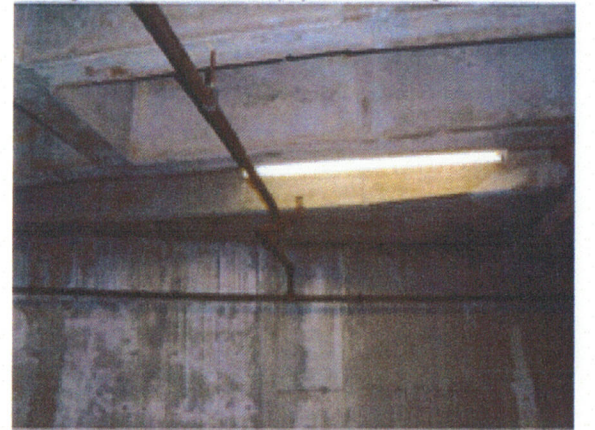
Garage Sprinkler Lines and Lighting

| 3C.04 | Garage Light Fixtures | X | | 12 Years | Approximately 25 @ \$500 ea. = \$12,500 | Water infiltration has seriously impacted these fixtures and associated conduit. They appear to be at the end of their useful life. Replacement must address both the fixtures and the viability of the associated wiring and conduit. |

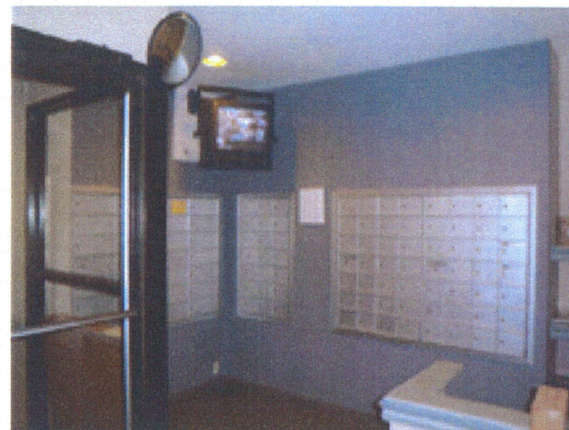
Lobby Mailboxes and Desk

| 3A.02 | Mailboxes | X | | 25 Years | Allow \$10,00 | Current condition is good. Assume replacement will be required late in the term. |
| 3A.03 | Reception Desk | X | | 12 Years | Allow \$7,500 | Current condition is good. Assume upgrade will be required once in the term. |

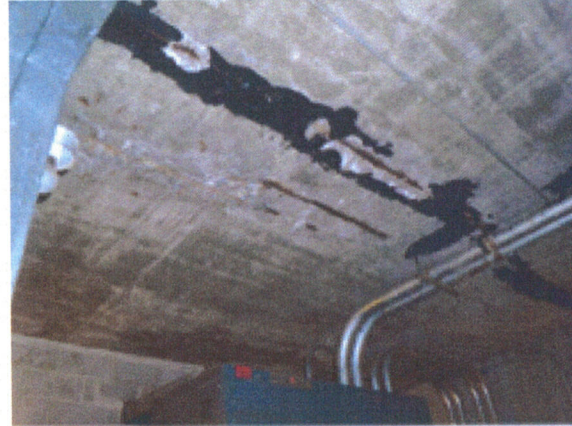
Substation Ceiling

In addition, the concrete ceilings in garage level spaces, particularly the room housing the electrical substation, should be monitored to verify that the new parking deck membrane has halted infiltration and consequent deterioration. Portions of the garage structure are showing deterioration from past water infiltration, a condition addressed in a report by this office and JSN Associates, Inc. dated August 29, 2006. The report found the deterioration not to be inimical to the building's structural integrity, and the infiltration causing the damage has reportedly been addressed successfully by the garage deck resurfacing. Handicapped accessibility is limited, but the Architectural Access Board (AAB) has reportedly agreed to the access procedures adopted by the association.

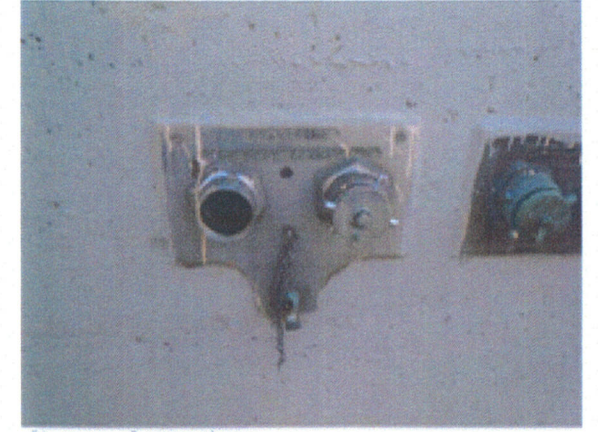
Siamese Connections

| 4A.02 | Sprinkler System Siamese Connection | X | | 50 Years | N/A | Replacement not anticipated during the term. |
