FACILITIES EVALUATION - 1105 MASSACHUSETTS AVENUE

April 25, 2011

Facilities Evaluation -- 1105 Massachusetts Avenue, Cambridge

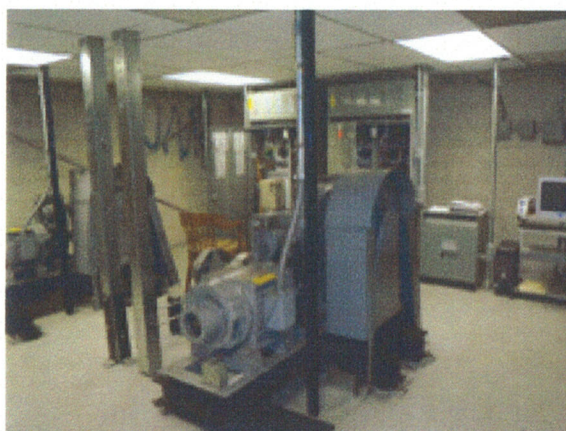
Elevator Motors and Switchgear

| 4F.01 | Elevator Machinery | X | | 20 Years | Motors (2) = \$8,000; Cables (2) = \$7,000 Generators (2): \$6,000; Controls: \$6,000 Condenser: \$3,000; Miscellaneous: \$5,000 Total: \$35,000 | The original installation was replaced with a Stanley system in 2007 for \$450,000. The work included new cabs, doors, cables and air conditioning of the machine room. Some component replacement may be required late in the term. |

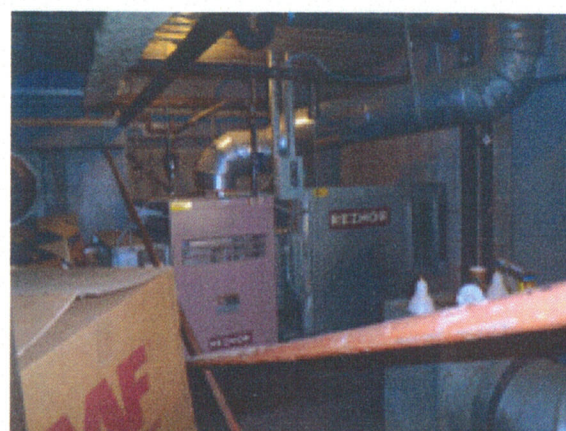
Common Area HVAC Unit

| 4F.03 | Common Area HVAC | X | | 20 Years | Air Handling Unit: \$12,000; Motors (9): \$1,000. Component Replacement: Allow \$5,000 | Reznor system installed in 2003. Assume replacement of some components will likely be required middle to late term. |

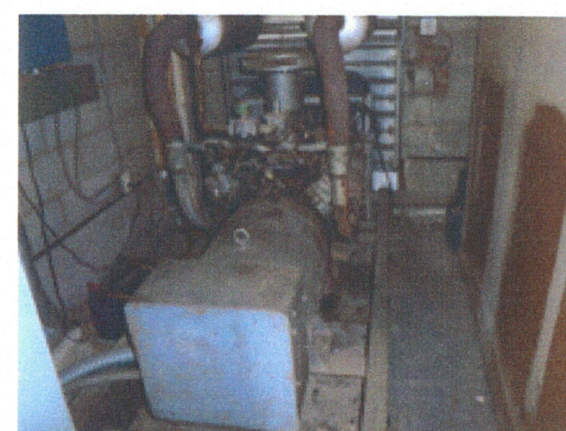
| 4F.07 | Emergency Generator | X | | 50 Years | | Generator should not need to be replaced over the term. |

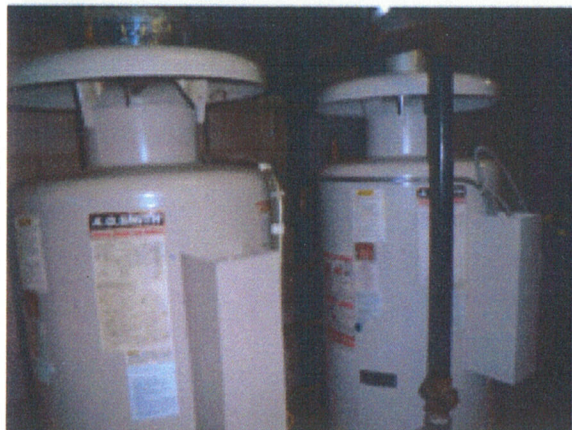
Hot Water Heaters

| 4F.02 | Hot Water System | X | | 8 Years | Heaters (2): \$15,000; Tanks (4): \$10,000; Mixing Valve: \$2,000; Miscellaneous: \$1,000 Total: \$28,500 | One heater was replaced in 2005, one in 2010. This is the 3rd round of replacements in the past 25 years. Holding tanks (500 gal.) installed in 2003 with new piping and controls to replace original single tank. Water quality will require frequent component replacement. |

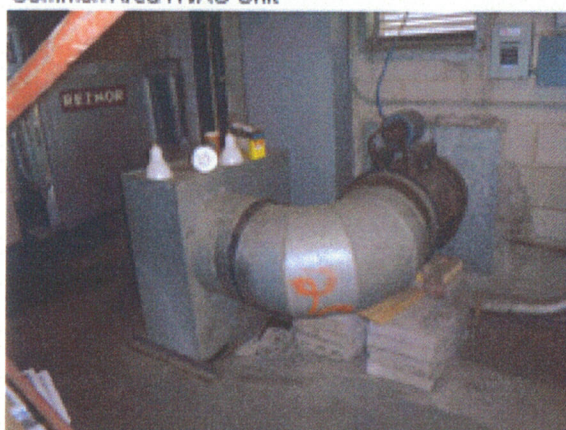
Utility Room Ventilator Fan

| 4F.05 | Roof Ventilator Fans | X | | 20 Years | 6 Fans @ \$1,500 = \$9,000 | Five fans installed 1974 and at the end of their useful life. One fan replaced 2007. |

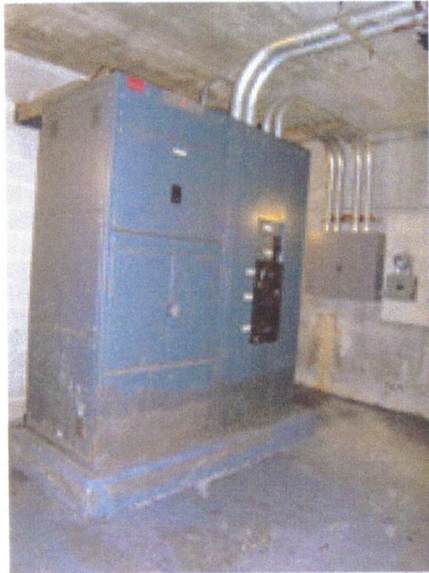
| 4D.09 | Electrical Substation | X | | 50 Years | N/A | Signs of past flooding apparent, but no current deficiencies reported or observed. This installation is unlikely to need major overhaul during the term. |

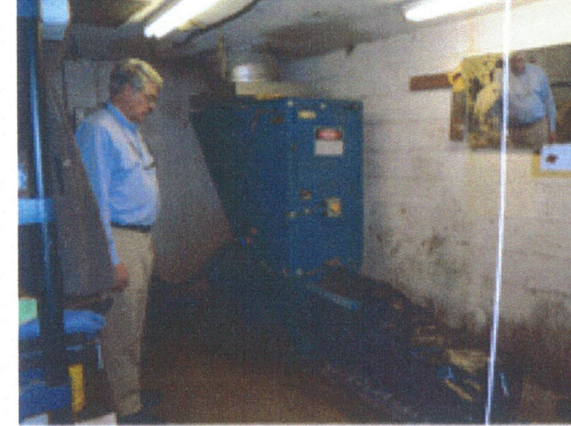
| 4E.02 | Trash Compactor | X | | 20 Years | Budget \$3,500 | This equipment was replaced in 2009 for \$14,000. Assume some component replacement may be necessary late in the term. |

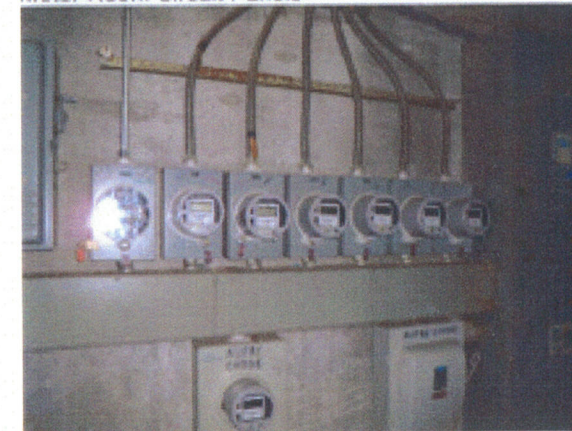
Electrical Meters

| 4D.10 | Meter Banks | | X | N/A | N/A | Assume major replacement or modification not required during the term. Maintain as required from yearly operations budget. |
